# Inspection Report

## Complete Building Inspection Services

**1 Bandicoot Drive, Blackbutt, NSW, 2529**

### Pest And Building Inspection

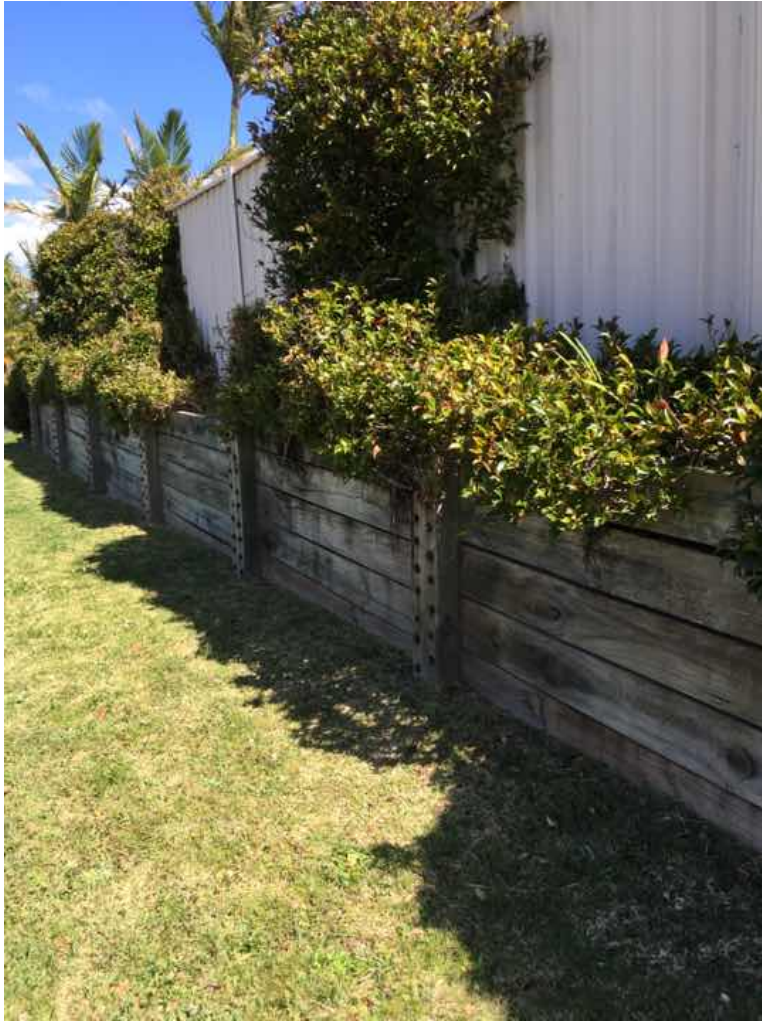
The retaining wall material is brick.

The retaining wall material is wood / timber.

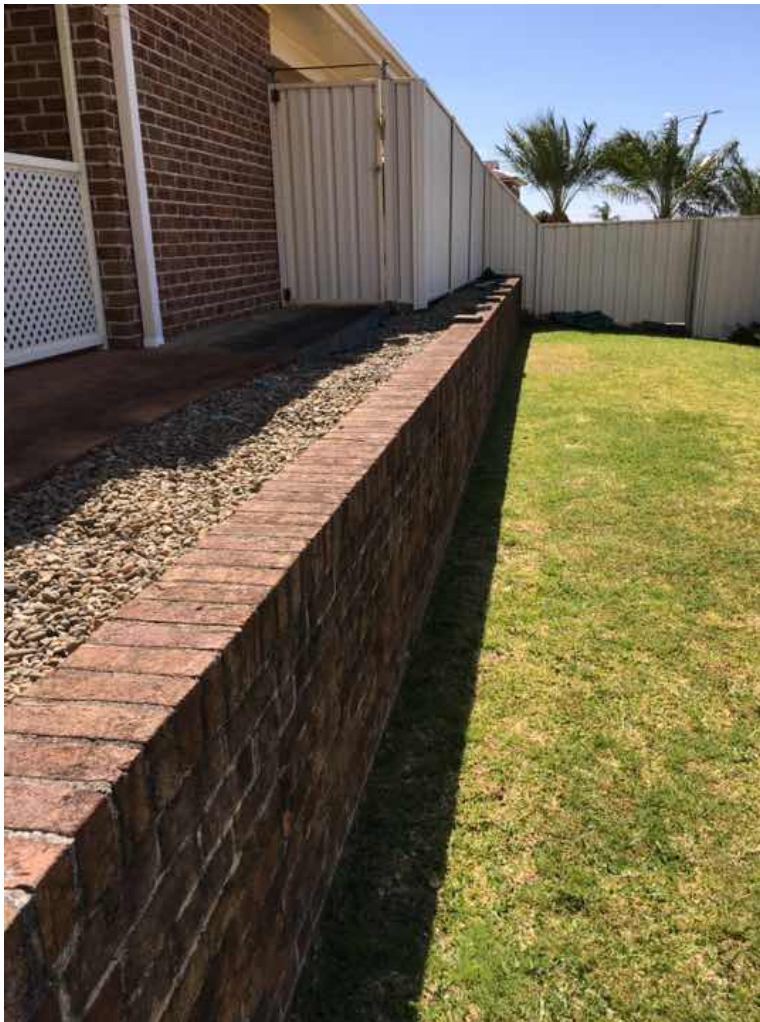
Of the visible areas, the general condition is serviceable or in reasonable condition for age of dwelling.

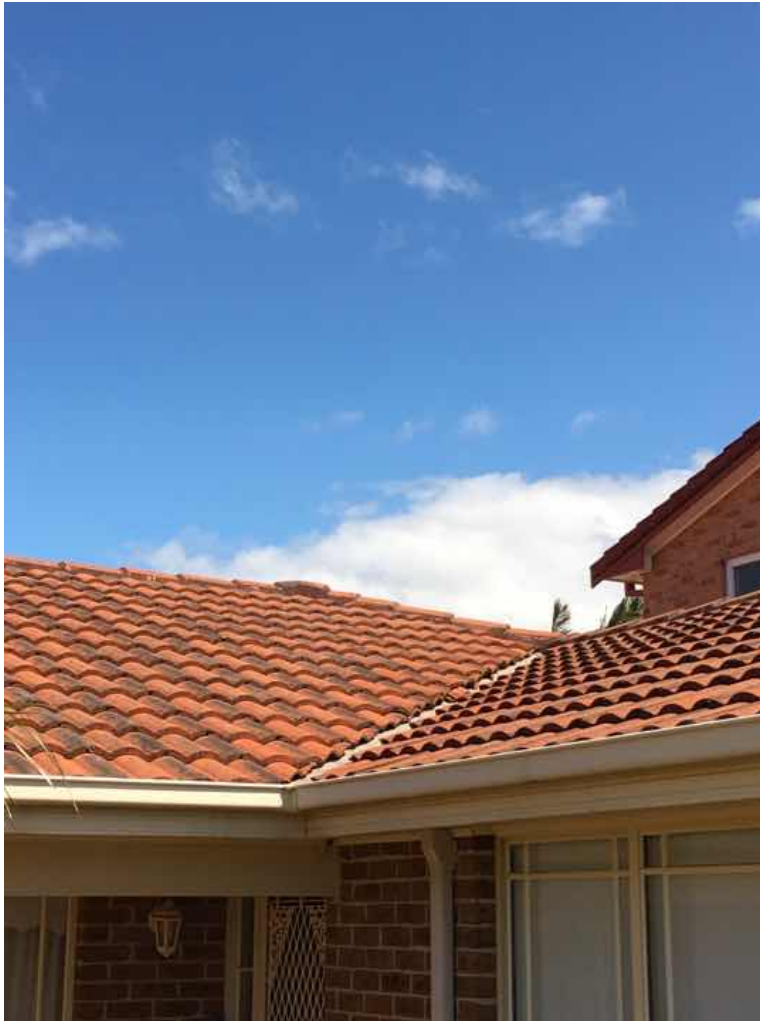
Of the visible areas, the general condition of the roof is in serviceable condition for the age.

Note: In the absence of rainfall there is no guarantee that the roof won't leak.

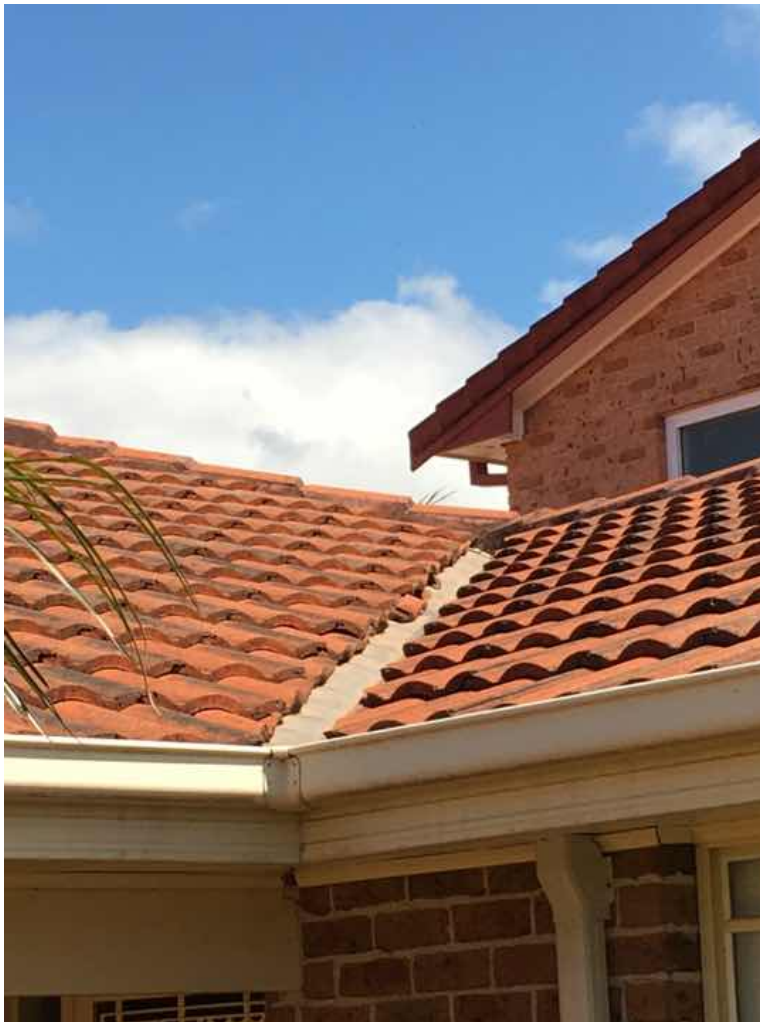
Visible section of The roof cladding appeared in a serviceable condition for the age of this dwelling. Annual maintenance inspection recommended.

Displaced tiles in areas noted. Reposition tiles to achieve adequate overlap and overhang etc as required.

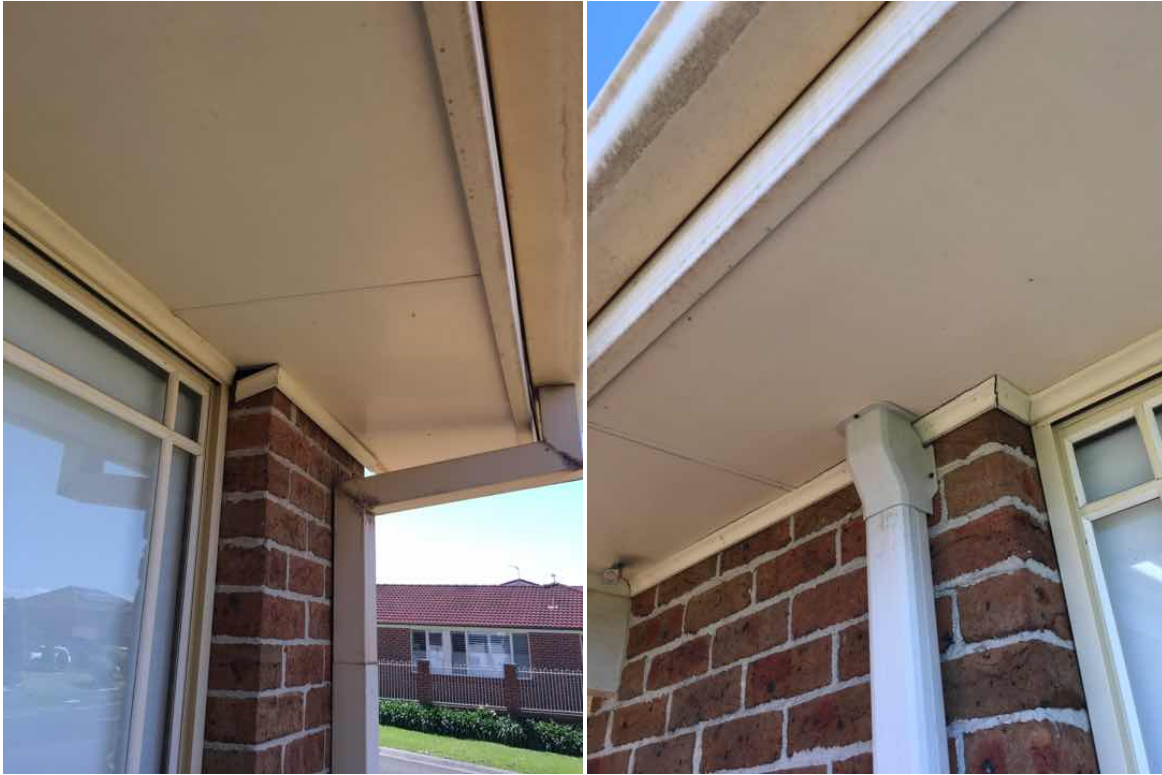
The soffit lining (eaves) are in a serviceable condition with no notable defects.

Timber trims to soffit linings loose in areas. Undertake maintenance to include refixing timbers and repaint etc.

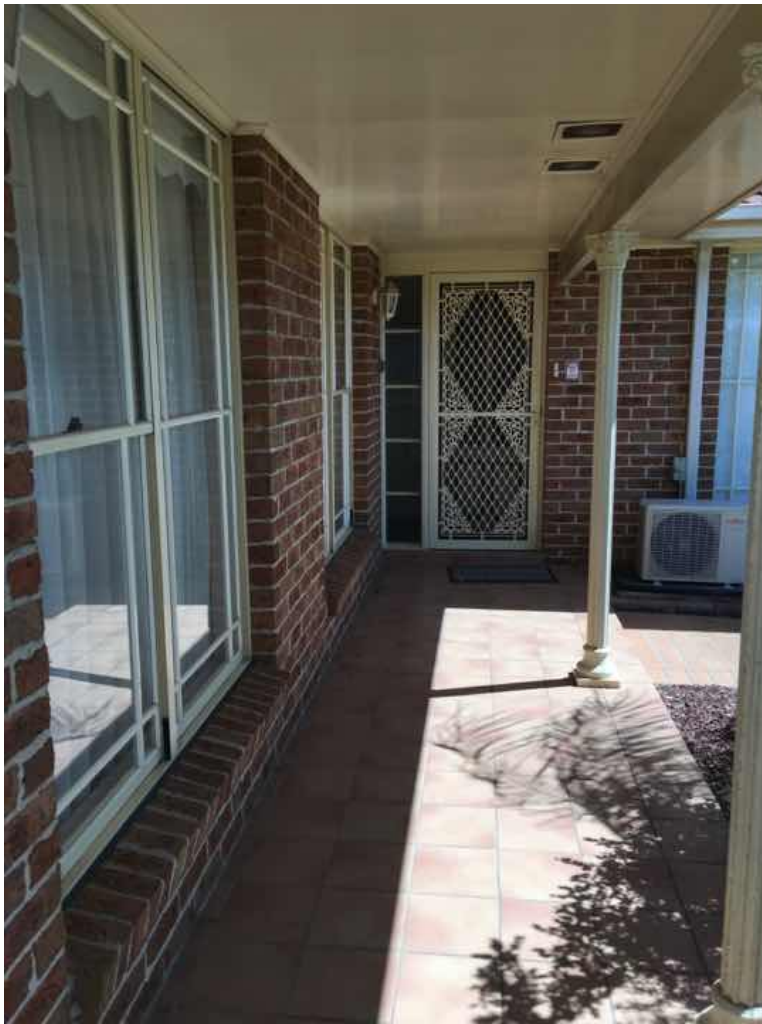
Visible sections of the Alfresco area are serviceable or in reasonable or condition for the age of this dwelling.

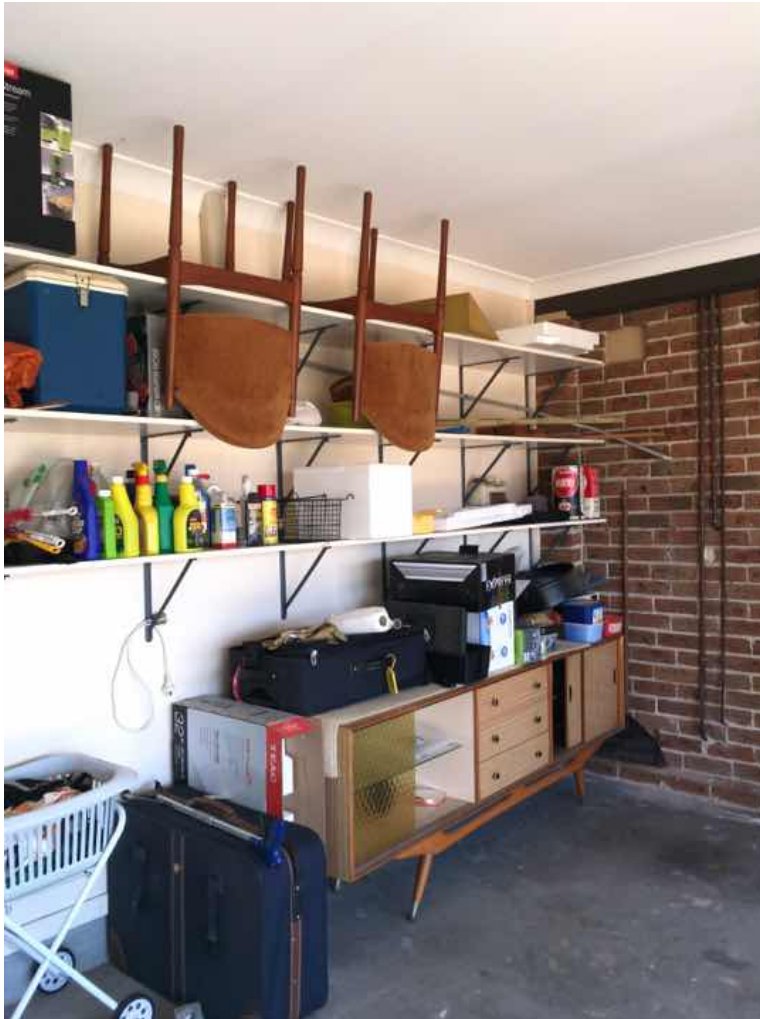
Storage items restricted a full and thorough inspection of this area. Defects may exist in the inaccessible areas. It is strongly recommended that full access be granted to enable a thorough inspection as there may be timber pest activity, damage or defects. Note: Where vehicles and storage has restricted a full inspection it is advised that this area be cleared so a full and unobstructed inspection can be carried out.

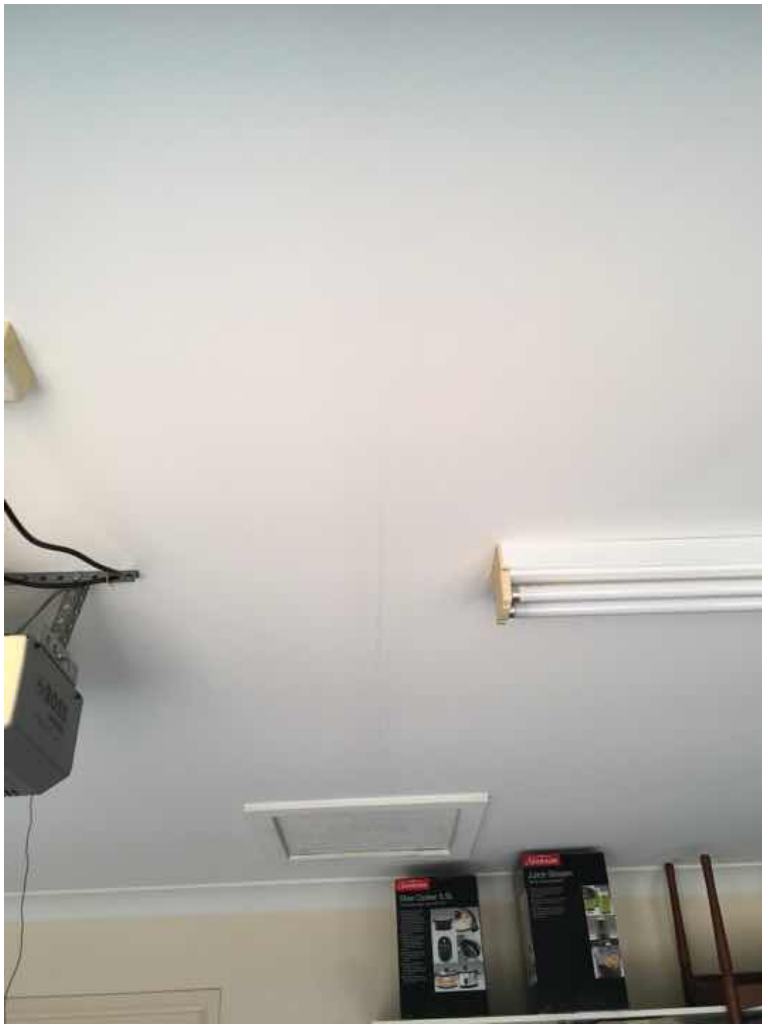
General ageing and/or denting and/or wear and/or previous patching and the like is evident on ceiling linings - Recommendations: All surface marks/damage, blistering paint, popped nails, sagging linings and settlement cracks/crazing etc to linings/joints/cornices should, with adequate surface preparation & maintenance/repairs/refixing, allow satisfactory redecoration/touch-up

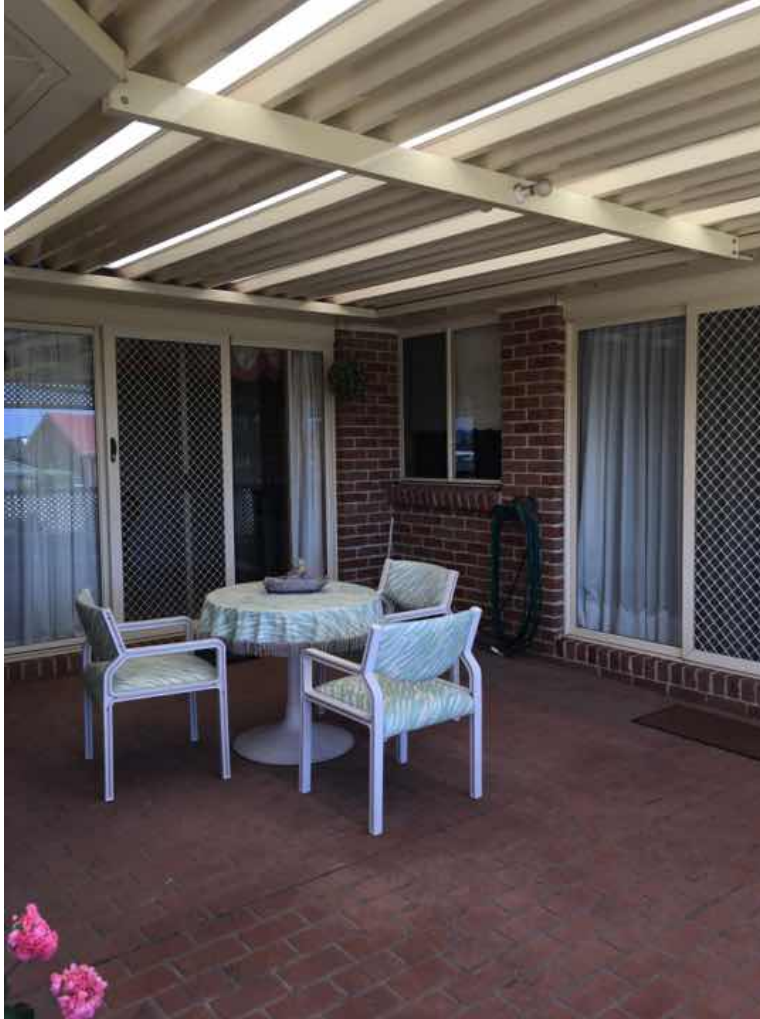
The Pergola is in a serviceable condition with no notable defects sighted.

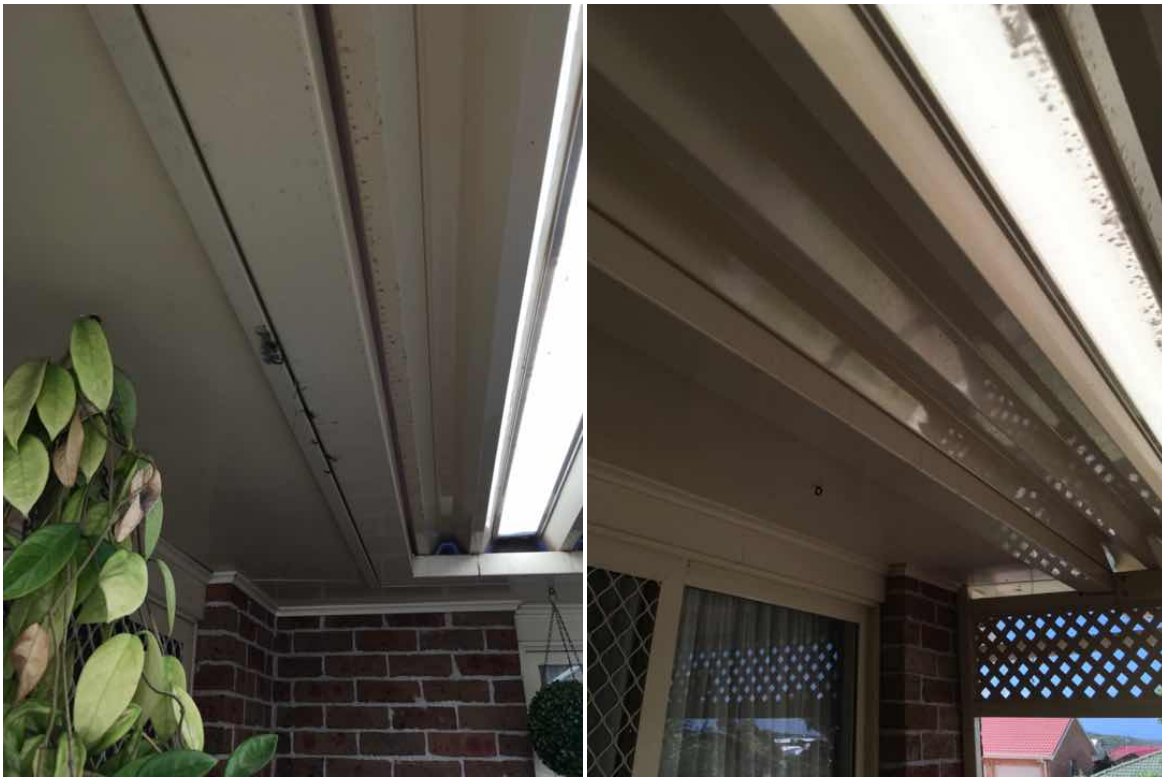
evidence of overflowing gutters likely caused by debris in guttering areas- this requires cleaning out to prevent blocking of down pipes and leaking into eaves and fascia. Recommendations: Have gutters cleaned and assessed for adequate fall. Also regularly clean to prevent ponding. Ponding water will contribute to rust.

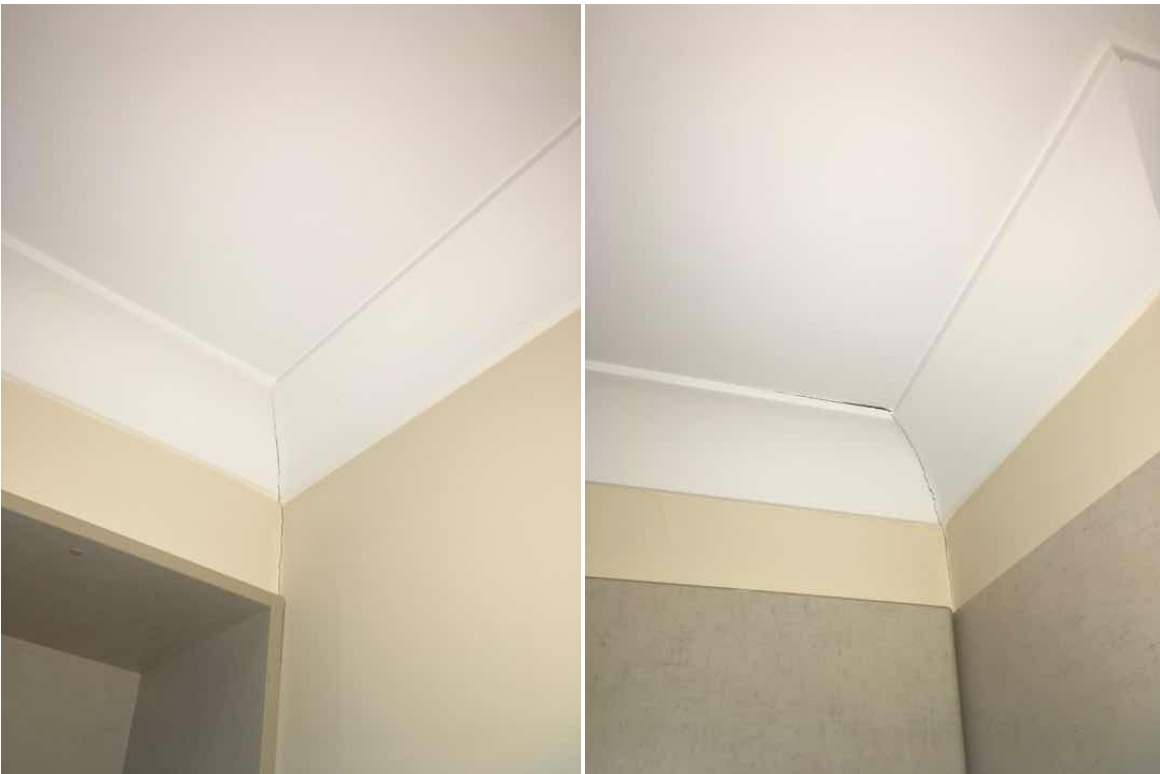
Internal ceiling linings appear in a serviceable condition with some minor surface marks consistent with age noted. General patching and paint touch ups should suffice. Note: Future patching and painting of settlement cracks etc to linings maybe required as the dwelling continues to age/settle or with variable weather conditions. This is considered a normal occurrence.

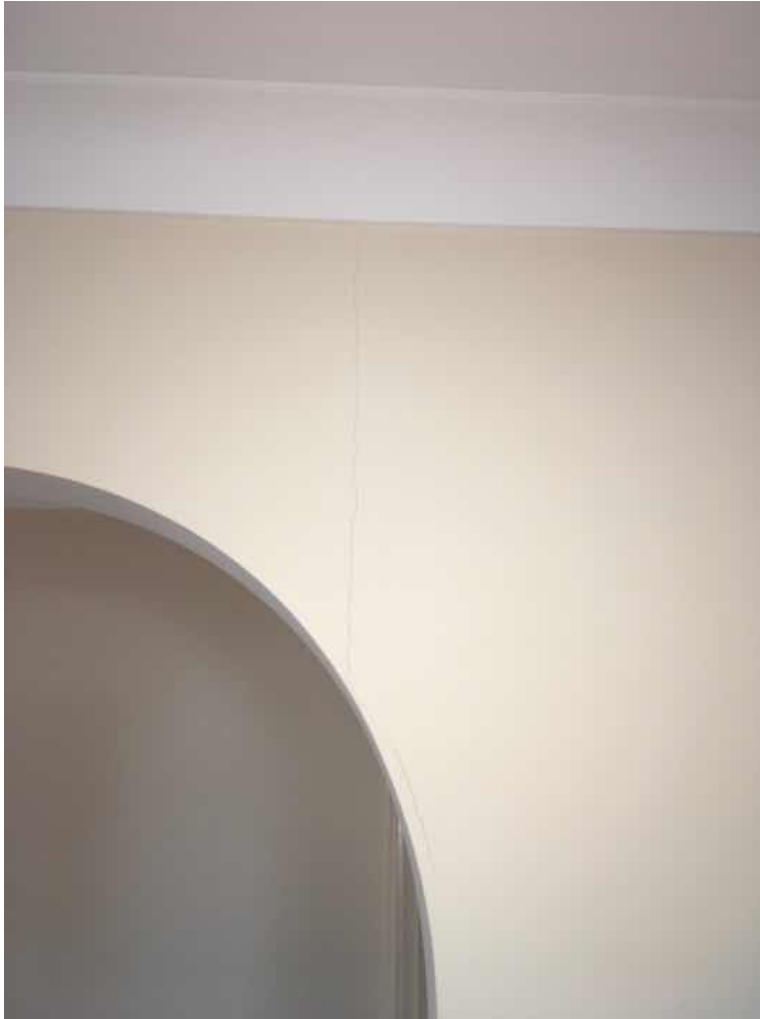
General age related wear and tear/surface marks etc consistent with the age of the dwelling is apparent. All/any surface marks/damage and settlement cracks/crazing etc to linings/joints should, with adequate surface preparation & maintenance/repairs, allow satisfactory redecoration/touch-up

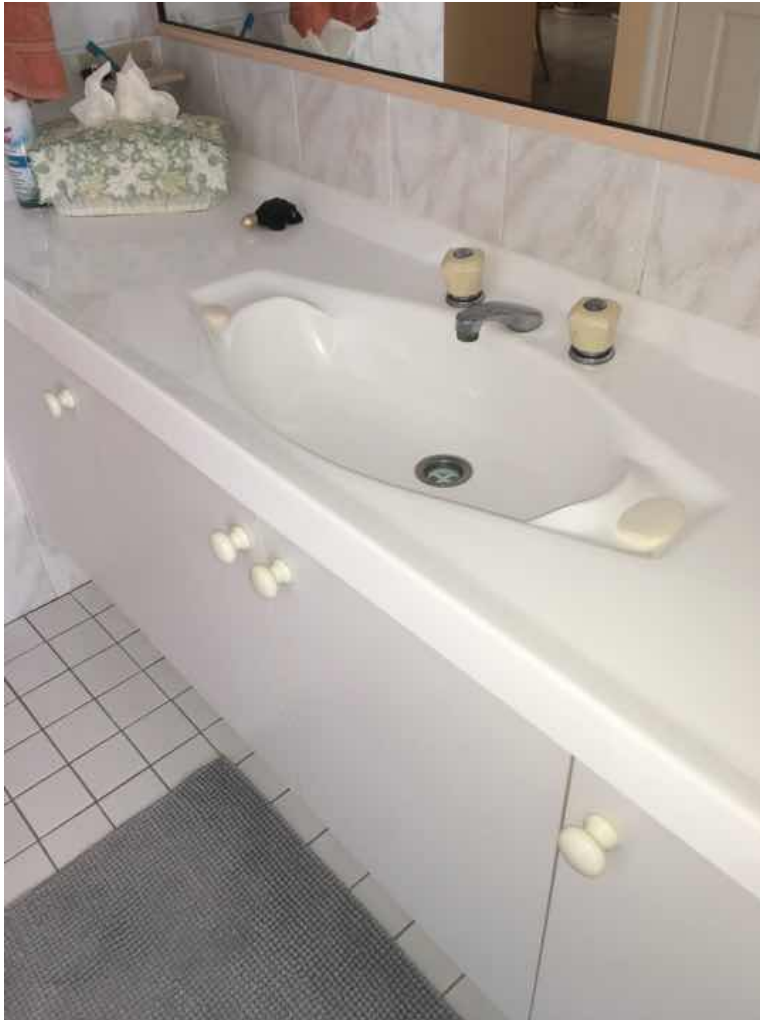
Vanity unit appears in a serviceable condition for the age of the bathroom with not notable defects apparent at the time of inspection.

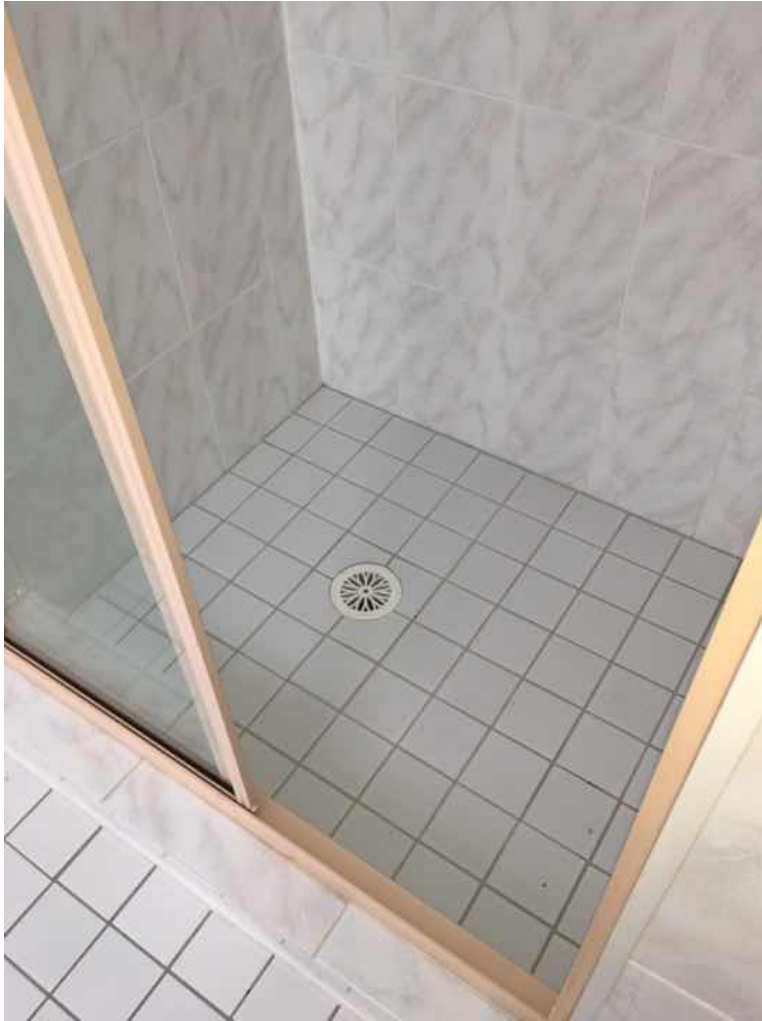
Shower appears in a serviceable condition with no leaks or notable defects detected at the time of inspection. Monitor shower screen for any water leaks after use and reseal joints to same

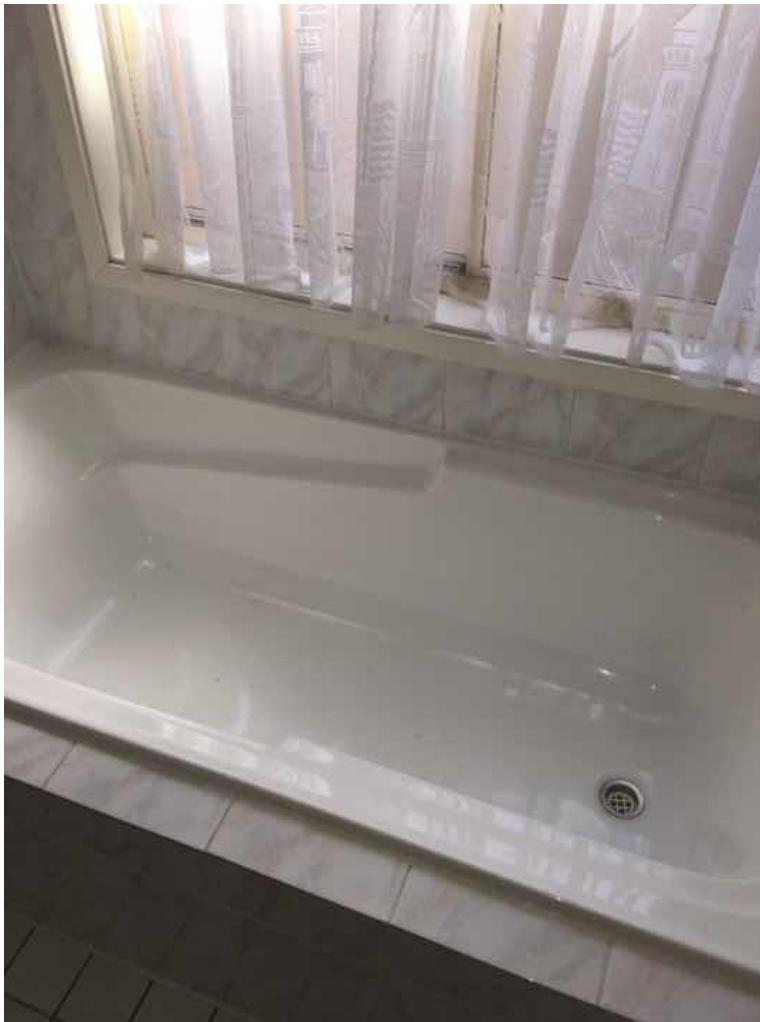
Bath was considered to be in good condition with no notable defects at the time of inspection. Maintain silicone to all joints and junctions to prevent any future water ingress as required.

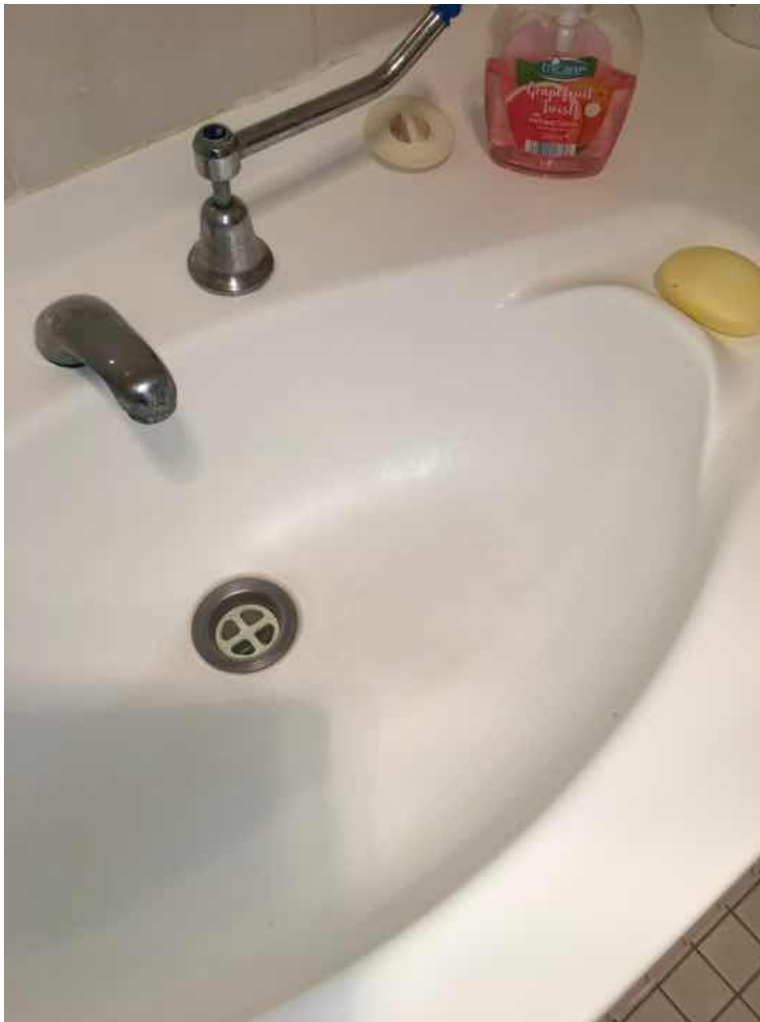
Age related wear and tear to vanity unit noted. Repairs are not considered necessary at this time.

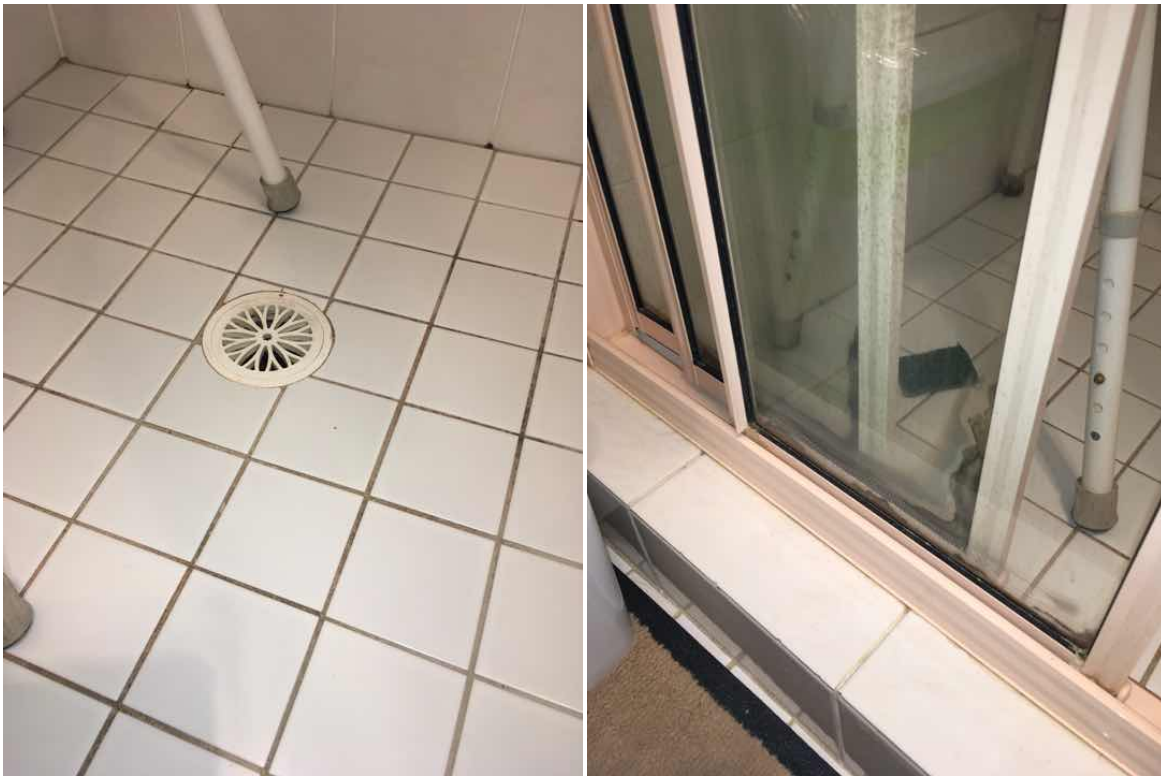
Tile grout deterioration associated with age and regular usage and is considered a common occurrence. Re-grouting and sealing the shower tiles and screen junctions is recommended. Note: without repairs water ingress behind tiles could cause tiles to become drummy, crack and result in future water leaks.

Delamination to glass shower screen noted. Future replacement is recommended

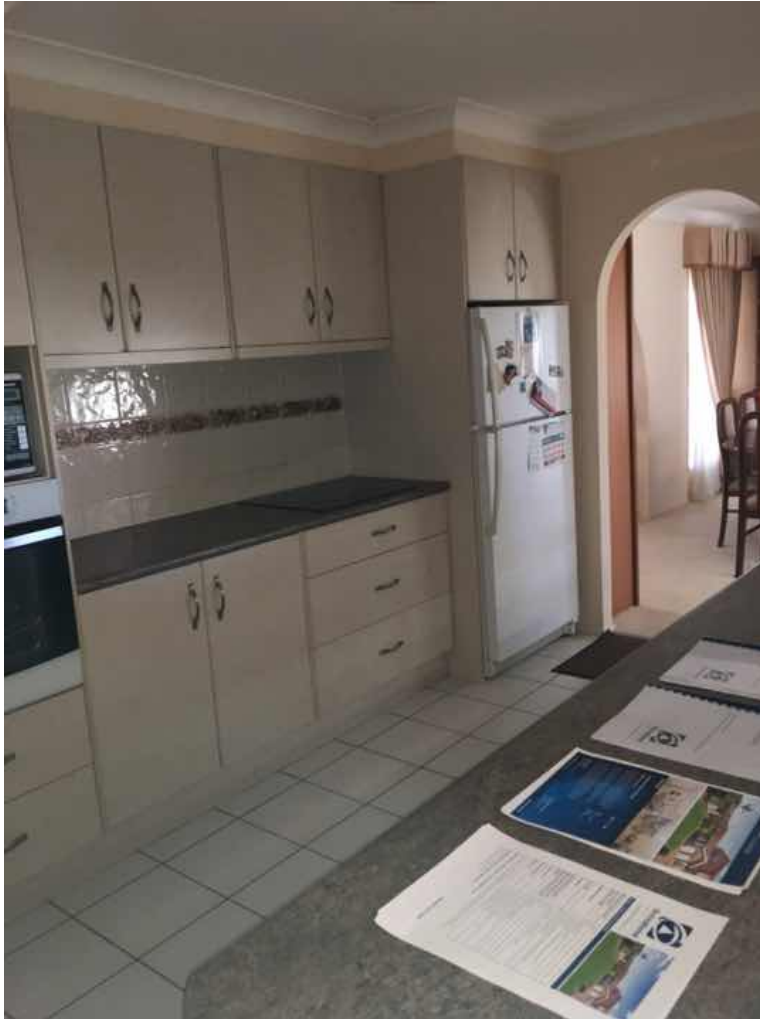
Of the visible areas, the general condition is serviceable or in reasonable condition for age of dwelling.

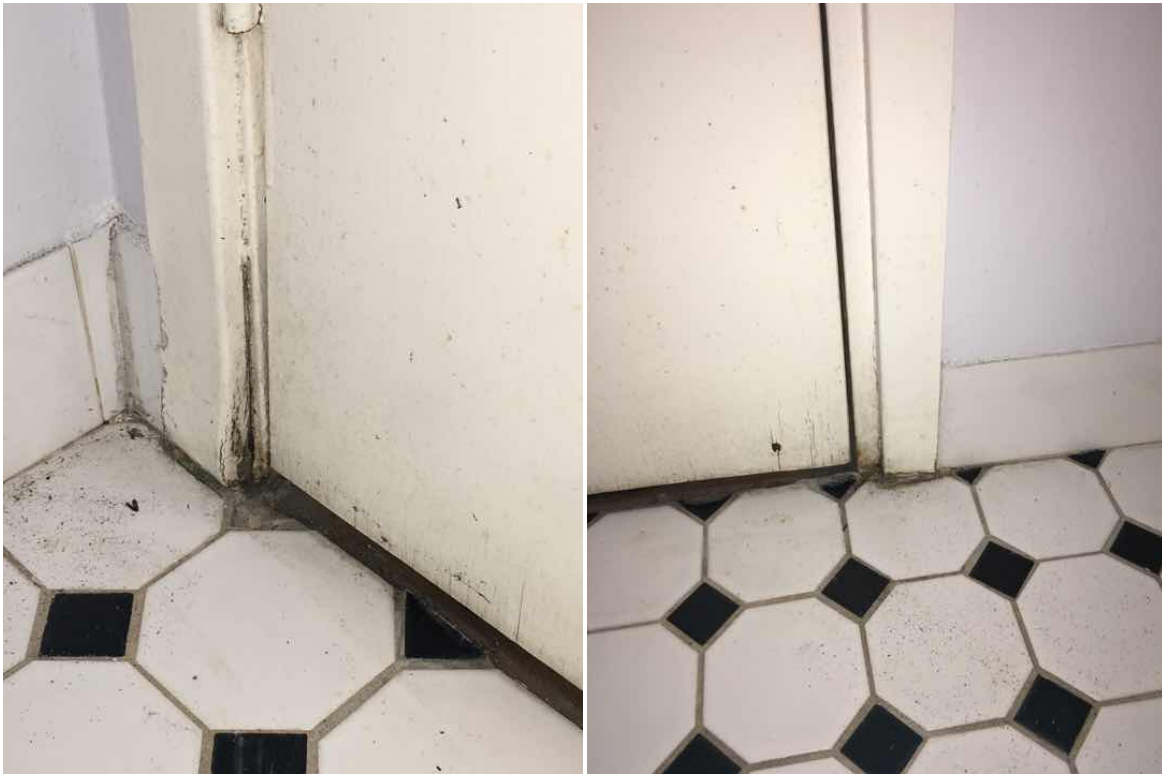
Swelling of MDF door architraves noted. MDF is not considered suitable for the use in wet areas. We recommend replacement of MDF architraves with a suitably timber architraves to include sealing and painting as required. Installing a suitable weather seal to the exterior door is also recommended to prevent water ingress.

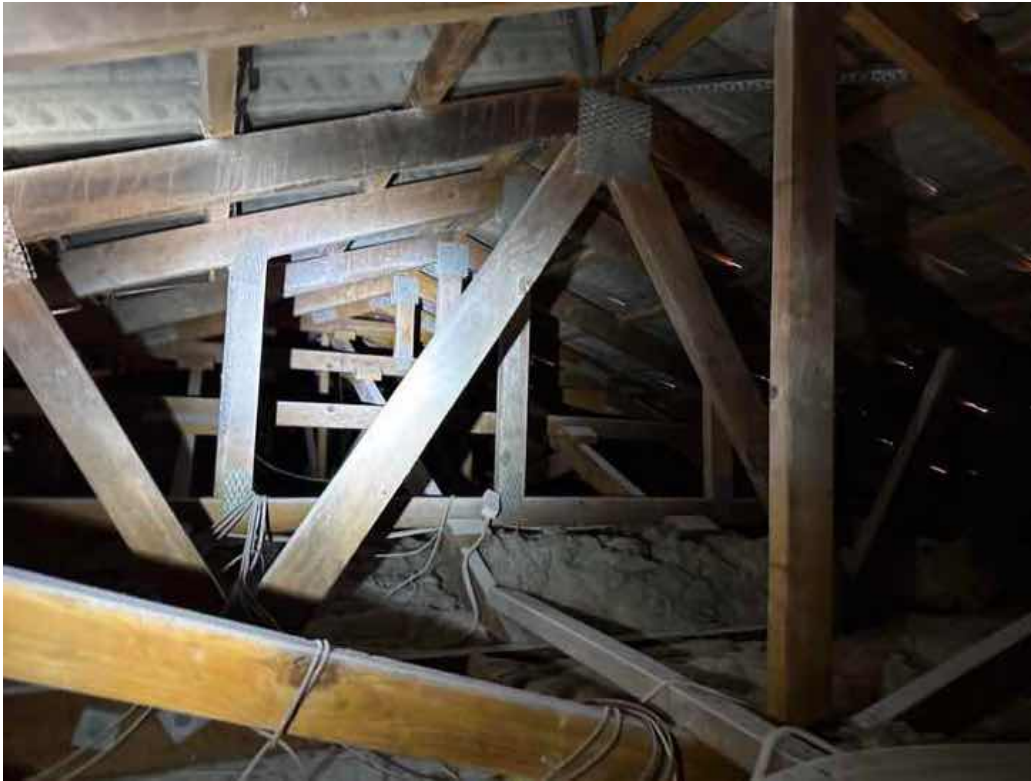
Accessible/visible roof timbers appeared in a serviceable condition. Truss roof frame appeared to be structurally adequate & well braced. Note: Monitor roof frame for any significant deflection/distortion and reassess/investigate further
